# 全髋置换术后内衬分离：1例报告和综述

魏聪聪, 杨 梦, 姚孟轩, 李会杰\*

(河北医科大学第三医院骨病科, 河北石家庄 050051)

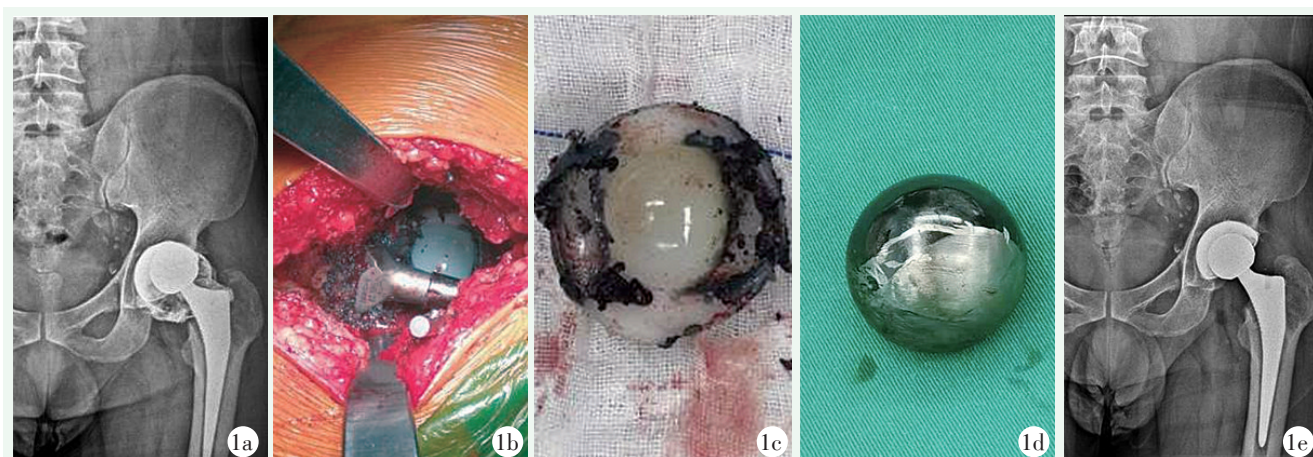
患者, 男, 40岁。于2020年行左髋关节置换术, 置入合适大小多孔涂层外杯, 高交联聚乙烯衬垫, 氧化锆合金股骨头和全涂层柄。术后4个月出现左髋部疼痛、活动时左髋异响。入院前10d, 左髋疼痛加重且难以忍受。减少活动和负重, 并口服药物治疗后, 仍觉疼痛剧烈, 遂入院治疗。专科查体: 有明显的跛行步态, 并且在负重行走时有明显的异响。左髋关节活动度降低, 主要表现为前屈70°、后伸5°、内收5°、外展40°、内旋5°、外旋5°。骨盆X线片显示假体上外侧存在偏心磨损, 假体周围见大量不规则骨化(图1a)。鉴别诊断包括髋关节置换术后假体

翻修手术前排除感染，因为白细胞计数、C 反应蛋白水平和红细胞沉降率均为阴性。仍选择高交联聚乙烯内衬，并且准备锆镍合金人工股骨头、钛合金股骨头柄和髋臼外杯来应对可能磨损严重或松动的髋关节假体。术中可见大量的黑色液体和黑色金属碎片分布于关节腔、外展肌和阔筋膜内（图 1b）。内衬外上侧部分发生磨损变形、脱出于髋臼外杯（图 1c）。股骨头表面也有一定程度的磨损（图 1d）。髋臼杯固定良

图 1 患者，男，40 岁，左髋关节置换术后内衬分离 1a: 翻修术前髋关节 X 线片示左侧股骨头假体位置偏心，假体周围见不规则骨化，密度不均匀的“云雾”状的高密度影考虑系磨损颗粒 1b: 翻修术中可见大量的黑色液体和黑色金属碎片分布于关节腔、外展肌和阔筋膜内 1c: 翻修术中可见高交联聚乙烯内衬部分发生严重磨损变形，内衬上的锁定齿和锁定卡槽发生严重变形和断裂 1d: 翻修术中可见氧化锆合金人工股骨头表面磨损 1e: 翻修术后骨盆 X 线片示假体的尺寸和位置可

好，未见明显磨损。术中发现股骨柄假体稳定，可以保留。此外，对肉芽肿组织和金属碎片进行彻底清理后，更换陶瓷球头和高交联聚乙烯内衬。复位人工髋关节后检查其活动范围良好，无髋关节撞击和脱位。

术前 Harris 髋关节功能评分 50 分。术后 1 年，Harris 评分为 80 分。术后骨盆 X 线片显示假体的尺寸和位置理想（图 1e）。末次随访时，患者双下肢等长，无跛行及术后其他并发症，左髋关节主动和被动活动良好，无明显疼痛不适。

加速锁定机制的失效<sup>[22]</sup>。而且与传统聚乙烯相比，高交联聚乙烯内衬的摩擦力矩随着假体球头尺寸增大而增大，进而引起更大的磨损<sup>[23]</sup>。高交联聚乙烯的出现使得髋关节置换术的近、远期疗效都取得了极大改善，同时磨损引起的骨溶解的发生率也明显降低，但代价是机械强度明显减小，这些变化降低了内衬抗拔出强度，增加内衬分离的风险<sup>[24, 25]</sup>。尽管本研究中内衬锁定机制可能对硬轴承是足够的，但对于机械强度较小的高交联聚乙烯可能是远远不够的，因为它会随着时间的推移而变形，进而导致锁定机制失效<sup>[26]</sup>。大量研究显示，高交联聚乙烯的磨损率为 $0.04 \sim 0.20 \text{ mm/年}$ <sup>[27-30]</sup>。此外，氧化锆合金股骨头假体的使用也降低了磨损率<sup>[31]</sup>。但本研究中所回收的置入物显示髋臼内衬边缘有严重磨损，推断，在内衬边缘的应力集中导致聚乙烯内衬过度磨损，形成磨损碎片且增加了股骨头和内衬假体间的粗糙程度，进而加速内衬的磨损并引起其变形和活动，内衬上的锁定齿和锁定卡槽发生严重变形或断裂，导致锁定机制失效引起内衬分离，进而使股骨头与髋臼外杯之间进一

步磨损。这种严重的磨损形成了大量金属碎片，在X线片上表现为密度不均匀的“云雾”状的高密度影(图1)。另外，股骨头存在严重磨损，而髋臼杯未见明显异常。本研究认为原因是：病程短，股骨头与髋臼杯的接触较少；氧化锆合金人工股骨头相对于钛合金髋臼杯有更易磨损。
